FIRE RISK ASSESSMENT REPORT
on behalf of Colchester Borough Homes

5-11 Gurdon Road
Colchester
CO2 7PB

Date assessed: 14th November 2022

Project Number: 86042

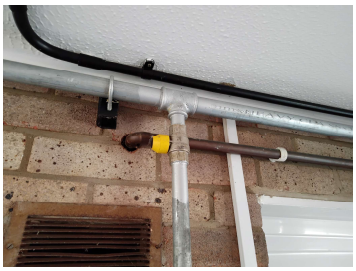
Hazard: Measures to Limit Fire Spread and Development	Priority: Medium
Issue Ref: ES/86042/005

Significant Findings: Gas pipe was seen entering building in common area leading to flats on ground and first floor.	
Action Required: Gas pipes must be boxed in with suitable materials that will prevent fire/smoke spread for a minimum 30 minutes, this will include pipe holes being filled on either side of flat/common area wall with fire resisting materials that achieve a minimum of thirty minutes of fire resistance.	
Actioned by:	**Date of Action:**
Comments Following Action:

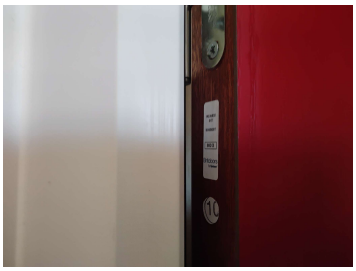
Hazard: Measures to Limit Fire Spread and Development	Priority: Medium
Issue Ref: ES/86042/006

Significant Findings: Flat entrance doors/frames are replacement composite fire doors (N.B. - From limited visual inspection of flat 9; certification not seen; adequacy of installation not confirmed).	
Action Required: As flat entrances have been fitted with composite door sets, these should have test evidence demonstrating they meet the performance requirement in Building Regulations guidance for fire resistance and smoke control from both sides. Management should confirm that suitable fire door test certificates are held and that these relate to the doors fitted.	
Actioned by:	**Date of Action:**
Comments Following Action:
