FIRE RISK ASSESSMENT REPORT
on behalf of Colchester Borough Homes

160-170 Hawthorn Avenue
Colchester
CO4 3YA

Project Number: 85236

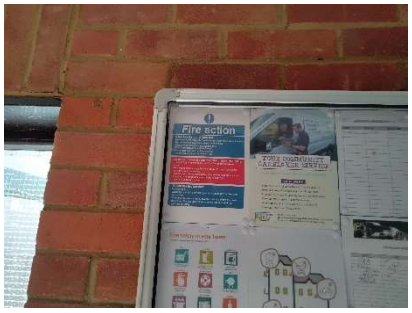
There is also ‘No smoking’ signage in common area and ‘Fire Door Keep Locked Shut’ signage on all escape doors and electrical riser cupboard door.

Stay Put fire action notice.
