FIRE RISK ASSESSMENT REPORT
on behalf of Colchester Borough Homes

19-23 Heather Close
Colchester
CO2 0EQ

Date assessed: 20th February 2023

Project Number: 86068

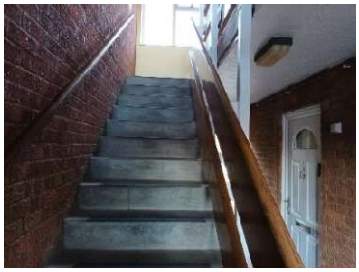
Hazard: Means of Escape	Priority: Advisory
Issue Ref: ES/86068/007

Significant Findings: There was no method of ventilation on the means of escape in the event of a fire. If a fire were to occur within the premises ventilation would allow the products of fire to ventilate easing escape conditions on the means of escape.	
Action Required: It is recommended that consideration is given to a mechanical or automatic means of ventilation in the common parts.

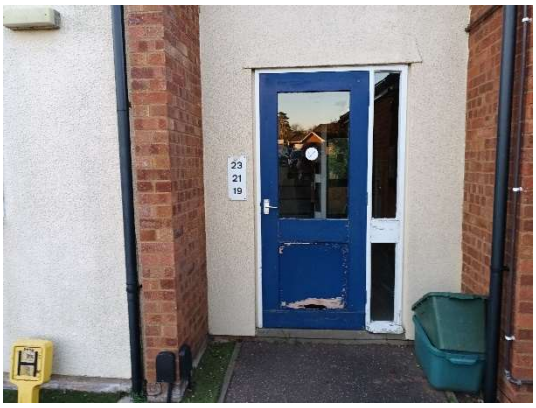
See significant findings-security of front exit/entrance.

Ground floor entrance with no means of locking and damaged door.

Hazard: Arson	Priority: Advisory
Issue Ref: ES/86068/003	
Significant Findings: The front fire exit door had a wooden panel damaged and no way of securing the door to prevent unauthorised access which could lead to arson.	
Action Required: It is recommended that the door is repaired or replaced and that a residents entry system is provided to prevent unwanted access via an electronic locking device controlled by the residents.	
Actioned by:	**Date of Action:**
Comments Following Action:
