# FIRE RISK ASSESSMENT REPORT
# on behalf of Colchester Borough Homes

# 9-15 Jackson Walk
# Colchester
# CO2 8RL

**Project Number: 86052**

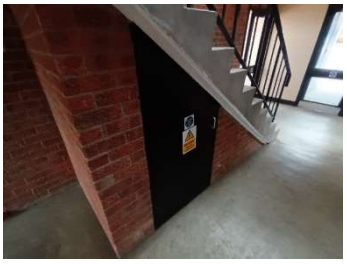
| **Hazard: Measures to Limit Fire Spread and Development** | **Priority: Medium** |
|---|---|
| ***Issue Ref:*** ES/86052/002 | |

| **Hazard: Measures to Limit Fire Spread and Development** | **Priority: Medium** |
|---|---|
| **Significant Findings:** There was no access to the electrical intake cupboard as the door could not be opened. It could not be ascertained if there is adequate compartmentation between the common areas and the cupboard. If there is inadequate compartmentation this may allow fire to spread through to the means of escape. | |

| **Hazard: Measures to Limit Fire Spread and Development** | **Priority: Medium** |
|---|---|
| **Action Required:** It is recommended that access is provided to the electrical intake cupboard and the above items are assessed for fire compartmentation. | |

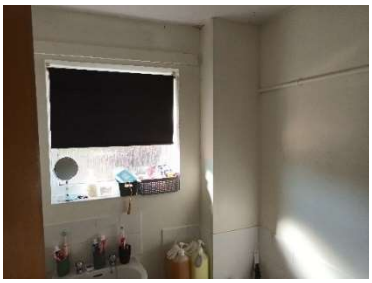
| Hazard: Measures to Limit Fire Spread and Development | Priority: Advisory |
|---|---|
| ***Issue Ref:*** ES/86052/010 | |

| Hazard: Measures to Limit Fire Spread and Development | Priority: Advisory |
|---|---|
| **Significant Findings:** There appeared to be service riser pipes boxed in. The Consultant was unable to confirm if these pipes had been adequately fire stopped to prevent the spread of fire, smoke, and products of combustion in the event of a fire. | |

| Hazard: Measures to Limit Fire Spread and Development | Priority: Advisory |
|---|---|
| **Action Required:** It is recommended that further investigation is completed to ascertain if the fire stopping is adequate within all flats. Records should be retained for verification. If alterations are required then a record should be recorded, retained, and produced on request. | |

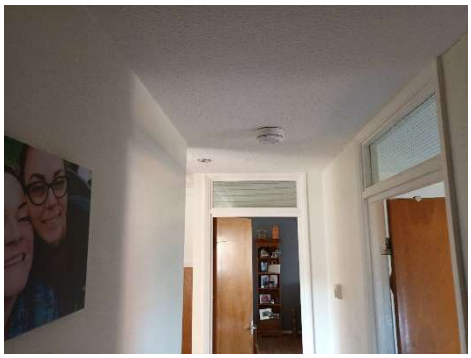
| Automatic Fire Detection and Alarm to LD3 standard, the minimum required standard for these premises is LD3. | |

In all flats, early warning of fire should be provided by means of smoke alarms installed in accordance with BS 5839-6. A category LD3 system should be considered the minimum in all circumstances. This is a system where there is one or more smoke alarms solely in the circulation spaces of a flat. Flats with more than one level and those with more than one hallway or circulation space will always require more than one smoke alarm.
