FIRE RISK ASSESSMENT REPORT
on behalf of Colchester Borough Homes

10-14 John Ball Walk
Colchester
CO1 1YE

Date assessed: 13th September 2022

Project Number: 85278

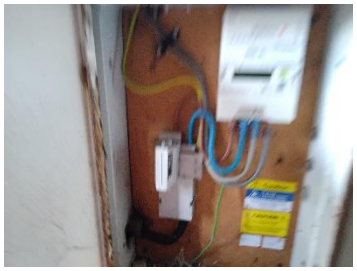
Hazard: Measures to Limit Fire Spread and Development	**Priority: Medium**
Issue Ref: ES/85278/008

Significant Findings: Meter cupboards are present within the communal area for each flat. Upon inspection of the meter cupboards the assessor found that cables have not been fire stopped as they enter into the cavity. A fire in these cupboards could spread into the cavity.	
Action Required: The meter cupboards should be fire stopped by a competent contractor using suitable fire resisting materials that conform to BS 476 and achieve a minimum of thirty minutes of fire resistance.	
Actioned by:	**Date of Action:**
Comments Following Action:
