FIRE RISK ASSESSMENT REPORT
on behalf of Colchester Borough Homes

1-4 Ken Cooke Court
Colchester
CO1 1FF

Project Number: 86201

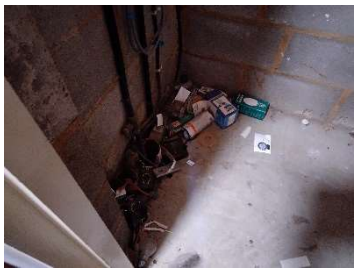
Hazard: Housekeeping	**Priority: Medium**
Issue Ref: ES/86201/001

Significant Findings: There were combustible items noted within the electrical intake cupboard at the time of inspection.	
Action Required: Management should contact residents to advise that the common area/escape routes should be kept free from all combustibles and/or trip hazards. A programme of regular checks should be put in place to ensure that the common area is kept clear.

There were combustible items noted within the electrical intake cupboard at the time of inspection.
