FIRE RISK ASSESSMENT REPORT
on behalf of Colchester Borough Homes

6-12 Ken Cooke Court
Colchester
CO1 1FF

Date assessed: 24th February 2023

Project Number: 86204

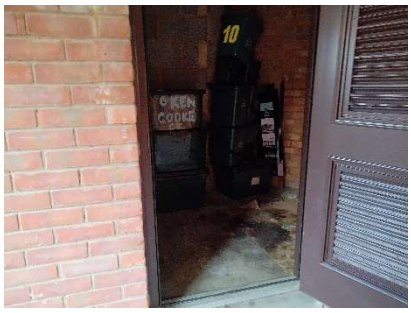
Refuse area within cupboard.

Intercom door system.

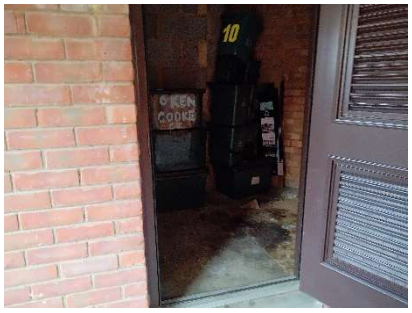
There were combustible items noted within the electrical intake cupboard at the time of inspection.

Items in riser cupboard.	
Refuse area.

Cleaning Rota.

Hazard: Housekeeping	**Priority: Medium**
Issue Ref: ES/86204/001	
Significant Findings: There were combustible items noted within the electrical intake cupboard at the time of inspection.	
Action Required: Management should contact residents to advise that the common area/escape routes should be kept free from all combustibles and/or trip hazards. A programme of regular checks should be put in place to ensure that the common area is kept clear.	
Actioned by:	**Date of Action:**
Comments Following Action:

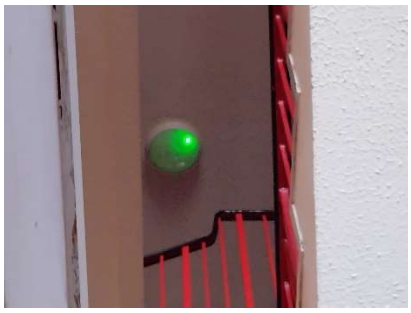
Emergency escape lighting.

Flick test switch.

Hazard: Emergency Escape Lighting	**Priority: Low**
Issue Ref: ES/86204/008	
Significant Findings: Non-maintained/Stand-by emergency lighting was seen within the common areas of the building, however, no confirmation seen that the lighting is subject to regular servicing and maintenance.	
Action Required: Organisations are required to test their emergency lighting at least once a year for the full test duration to ensure that they are still capable of providing emergency lighting for the period required. If a system fails the test, then the backup battery will have to be replaced. BS 5266-8 / BS EN 50172 dictate that the responsible persons must test all the emergency lighting systems in a building at least once a month. Emergency lighting signage guidelines require all signs and luminaries to illuminate and be present and clean. The monthly test is typically a quick 'flick' test performed to ensure that the emergency lighting switches work. Annual testing must be done to check if the lights remain on for the duration recommended by British Standard. All the lights must continue to function as they should once the test is over. Those that do not must be replaced.
