FIRE RISK ASSESSMENT REPORT
on behalf of Colchester Borough Homes

19-24 Ladbrook Drive
Colchester
CO2 8RW

Project Number: 86055

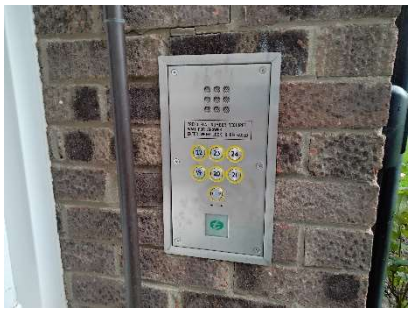
Block is secured via an access control system
