FIRE RISK ASSESSMENT REPORT
on behalf of Colchester Borough Homes

1-6 Lilac Tree Court
Colchester
CO4 3LN

Date assessed: 13th March 2023

Project Number: 86932

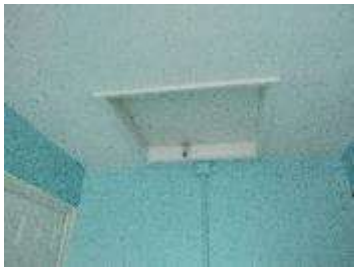
Hazard: Measures to Limit Fire Spread and Development	**Priority: Low**
Issue Ref: ES/86932/005	
Significant Findings: There was no access to check the compartmentation within the roof space due to padlocks fitted and no key supplied.

Action Required: Compartmentation within the loft hatch area to be checked for compartmentation between flats. If compartmentation appears to be poor, then all findings above should be fire stopped by a competent contractor using suitable fire resisting materials that achieve a minimum of thirty minutes of fire resistance.
