FIRE RISK ASSESSMENT REPORT
on behalf of Colchester Borough Homes

7-12 Lilac Tree Court
Colchester
CO4 3LN

Date assessed: 13th March 2023

Project Number: 86933

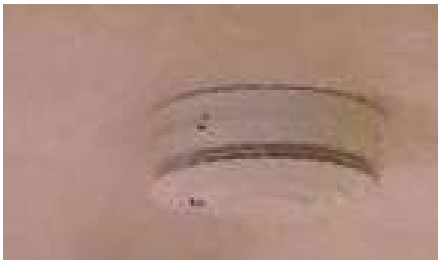
Smoke detection

There is no communal automatic fire detection on the premises as per guidance outlined in Local Government Association - Fire Safety in Purpose Built Flats, Section 20.4: '. In 'general needs' blocks designed to support a 'stay put' policy, it is unnecessary and undesirable for a fire alarm system to be provided. A communal fire detection and alarm system will inevitably lead to a proliferation of false alarms. This will impose a burden on fire and rescue services and lead to residents ignoring warnings of genuine fires.' there was however, LD3 smoke detection within the hallway of the flats. This is taken from sampled flat 9.
