# FIRE RISK ASSESSMENT REPORT
# on behalf of Colchester Borough Homes

# 59-63a Magnolia Drive
# Colchester
# CO4 3LP

**Date assessed: 23rd March 2023**

**Project Number: 87034**

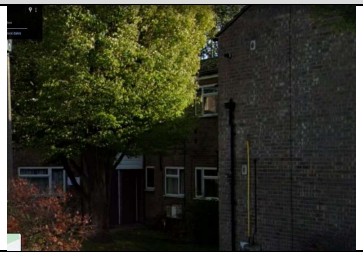
| **Hazard: Emergency Escape Lighting** | **Priority: Low** |
|---|---|
| ***Issue Ref:*** ES/87034/007 | |

| **Hazard: Emergency Escape Lighting** | **Priority: Low** |
|---|---|
| **Significant Findings:** A large tree is outside the block that could affect light to the common means of escape. | |

| **Hazard: Emergency Escape Lighting** | **Priority: Low** |
|---|---|
| **Action Required:** Review lighting levels and consider installing emergency lighting as necessary or cut the tree back. | |
