FIRE RISK ASSESSMENT REPORT
on behalf of Colchester Borough Homes

80-86 Maidenburgh Street
Colchester
CO1 1TT

Date assessed: 28th February 2023

Project Number: 87059

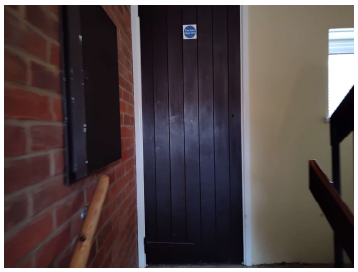
Hazard: Measures to Limit Fire Spread and Development	Priority: Low
Issue Ref: ES/87059/006	
Significant Findings: The assessor noted that there are no cold smoke seals or intumescent strips installed to the frame/door of the electrical riser cupboard on first floor.

The assessor noted that there are no cold smoke seals or intumescent strips installed to the frame/door of the electrical riser cupboard on first floor.

Action Required: Install cold smoke seals and intumescent strips to the top edges and both sides of the communal fire door/frame.	
Actioned by:	**Date of Action:**
Comments Following Action:

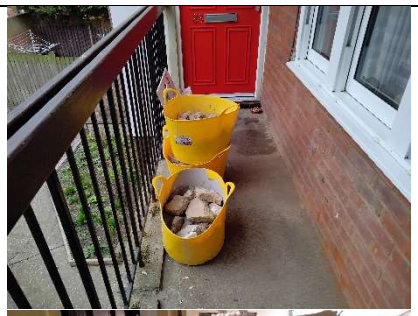
Combustibles at front of building

Hazard: Housekeeping	**Priority: Low**
Issue Ref: ES/87059/002	
Significant Findings: There were combustible items noted outside the front of the building at the time of inspection.	
Action Required: Management should contact residents to advise that the areas within and around the building should be kept free from all combustibles. A programme of regular checks should be put in place to ensure that the common area is kept clear.	
Actioned by:	**Date of Action:**
Comments Following Action:

There were combustible items noted outside the front of the building at the time of inspection.

There were combustible items and trip hazards in the escape routes on first and second floor.
