FIRE RISK ASSESSMENT REPORT
on behalf of Colchester Borough Homes

96-100 Maidenburgh Street
Colchester
CO1 1TT

Date assessed: 14th September 2022

Project Number: 85239

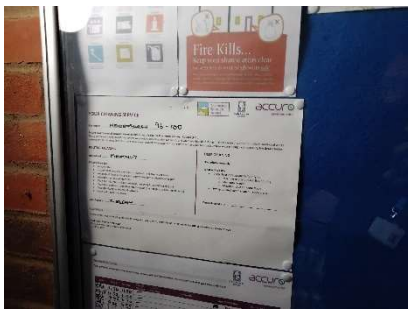
Hazard: Housekeeping	**Priority: Medium**
Issue Ref: ES/85239/013	
Significant Findings: There were trip hazards noted within the common escape routes at the time of inspection.	
Action Required: Management should contact residents to advise that the common area/escape routes should be kept free from all trip hazards. A programme of regular checks should be put in place to ensure that the common area is kept clear.	
Actioned by:	**Date of Action:**
Comments Following Action:

Items on second floor common area	
Cleaning rota on notice board in common area
