FIRE RISK ASSESSMENT REPORT
on behalf of Colchester Borough Homes

21-24 Mason Close
Colchester
CO2 9BH

Date assessed: 20th February 2023

Project Number: 86046

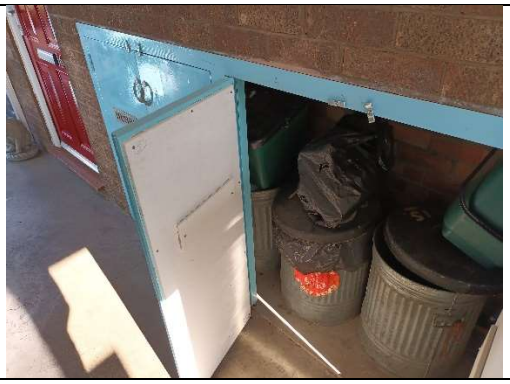
Hazard: Measures to Limit Fire Spread and Development	**Priority: Medium**
Issue Ref: ES/86046/003	
Significant Findings: Ground floor storage cupboards on the means of escape are being used to store combustible rubbish/combustible items. If the combustible items were set alight the means of escape the flats would be impacted. The doors to the cupboards are not fire doors, cannot be kept locked shut, have no intumescent strips.	
Action Required: It is recommended that this facility is decommissioned and no longer used for waste storage. It is also recommended that the Fire Door sets should be compliant/conform to BS 8214:2016 (Code of practice for Timber-based fire door assemblies) and BS 476- 22:1987 or BS EN 1634-1:2014, maintained in keep locked shut, a good state of repair, and be fitted with all necessary features (e.g., intumescent strips and cold smoke seals.	
Actioned by:	**Date of Action:**

Ground floor storage cupboards on the means of escape are being used to store combustible rubbish/combustible items.

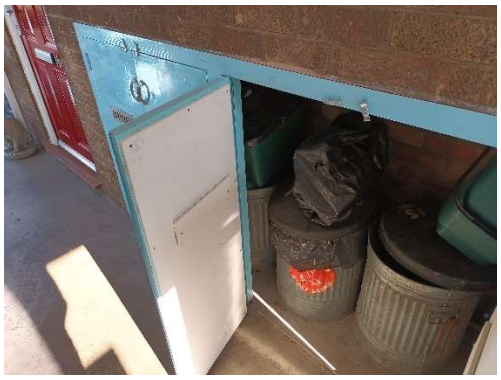
External waste facilities are located to the side of the premises which consists of wheelie bins. General housekeeping was in fair order throughout the premises. The only issue observed on the day of the assessment being rubbish bins stored on the means of escape. See significant findings.

Rubbish bins stored on the means of escape. Please refer to: ES/86046/003

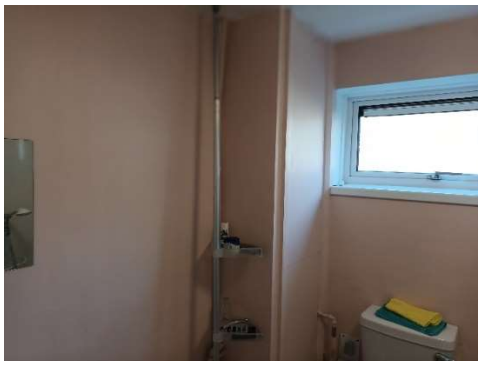
Hazard: Measures to Limit Fire Spread and Development	**Priority: Advisory**
Issue Ref: ES/86046/004	
Significant Findings: The Consultant advises that there appeared to be service riser pipes boxed in. The Consultant was unable to confirm if these pipes had been adequately fire stopped to prevent the spread of fire, smoke, and products of combustion in the event of a fire	
Action Required: It is recommended that a survey is completed to ensure fire stopping has been completed to service risers to an adequate standard in all flats, any remedial works should be completed by a competent person and records provided and retained to verify these works.

The assessor noted that there may be service riser within the flats that houses the soil and vent pipe. See significant findings.

Riser boxed in Bathroom.
