FIRE RISK ASSESSMENT REPORT
on behalf of Colchester Borough Homes

9-14 Mason Close
Colchester
CO2 9BH

Date assessed: 20th February 2023

Project Number: 86047

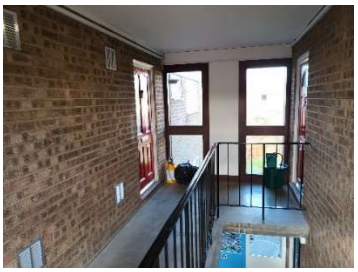
Hazard: Identifying People at Risk	Priority: Medium
Issue Ref: ES/86047/008

Significant Findings: Combustible items were left on the first floor landing on the means of escape. In the event of a fire these items could become a trip hazard prevent escape or they could provide fuel for a fire.	
Action Required: It is recommended that these combustible items are removed and information is supplied to the residents on the hazards of storing items of the means of escape, That a system is set up to monitor these areas to prevent it occurring again.	
Actioned by:	**Date of Action:**
Comments Following Action:

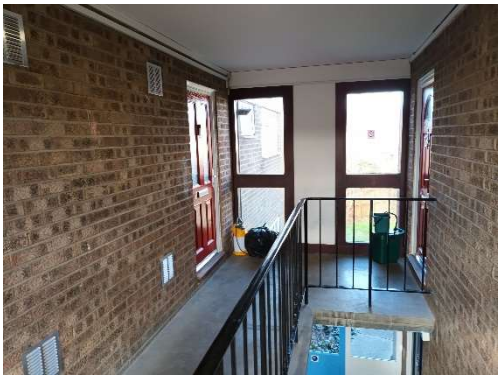
External waste facilities are located to the side of the premises which consists of wheelie bins. General housekeeping was in fair order throughout the premises. The only issue observed on the day of the assessment being rubbish bins stores and combustible items on the means of escape. See significant findings.

Combustible items on the means of escape.
