FIRE RISK ASSESSMENT REPORT
on behalf of Colchester Borough Homes

1-6 Meopham Court
Colchester
CO2 8SW

Date assessed: 7th December 2022

Project Number: 86061

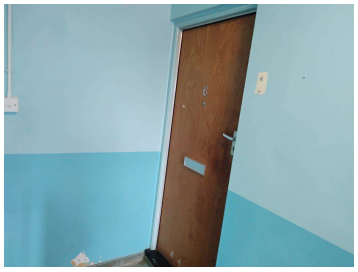
Hazard: Measures to Limit Fire Spread and Development	Priority: Medium
Issue Ref: ES/86061/008

Significant Findings: Flat 6 entrance door appears to be replacement timber door. As no access was possible, inspection of door was not possible.	
Action Required: Management should confirm that suitable fire door test certificates are held and that these relate to the doors fitted. If adequacy cannot be confirmed it may be necessary for door sets to be replaced under a risk-based programme.	
Actioned by:	**Date of Action:**
Comments Following Action:

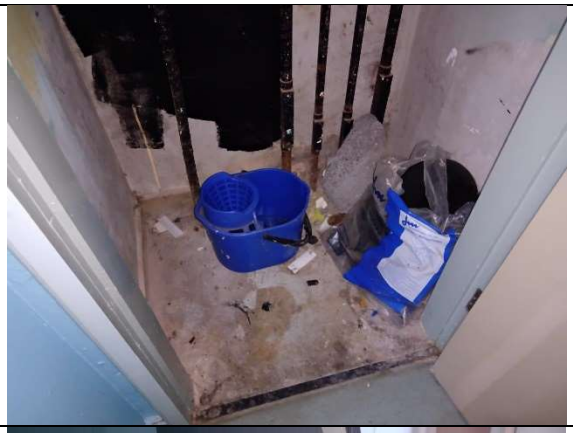
Hazard: Housekeeping	**Priority: Medium**
Issue Ref: ES/86061/001	
Significant Findings: There were combustible items noted within the electrical intake cupboard at the time of inspection.	
Action Required: Management should contact residents to advise that the common area/escape routes should be kept free from all combustibles and/or trip hazards. A programme of regular checks should be put in place to ensure that the common area is kept clear.

There were combustible items noted within the electrical intake cupboard at the time of inspection

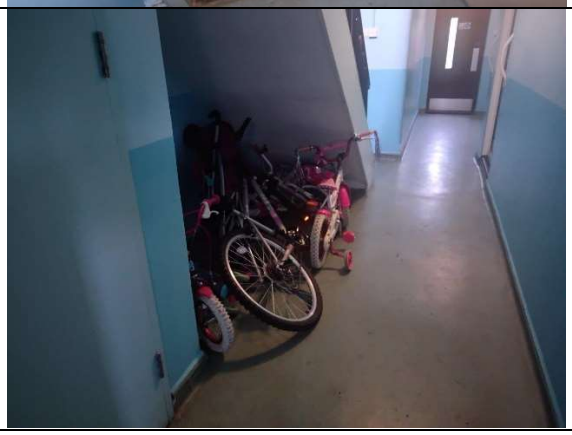
Hazard: Housekeeping	Priority: Medium
Issue Ref: ES/86061/002	
Significant Findings: There were trip hazards noted within the common escape routes at the time of inspection.	
Action Required: Management should contact residents to advise that the common area/escape routes should be kept free from all combustibles and/or trip hazards. A programme of regular checks should be put in place to ensure that the common area is kept clear.	
Actioned by:	**Date of Action:**
Comments Following Action:

There were trip hazards noted within the common escape routes at the time of inspection
