FIRE RISK ASSESSMENT REPORT
on behalf of Colchester Borough Homes

11-14 Middlewick Close
Colchester
CO2 8PH

Date assessed: 25th November 2022

Project Number: 86095

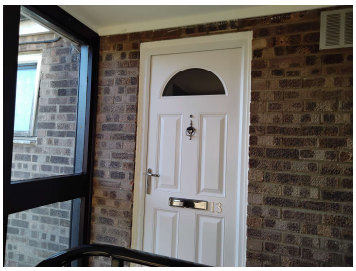
Hazard: Measures to Limit Fire Spread and Development	Priority: Medium
Issue Ref: ES/86095/005

Significant Findings: Flat entrance doors/frames are replacement composite fire doors (N.B. - From limited visual inspection no flats were inspected; certification not seen; adequacy of installation not confirmed).	
Action Required: As flat entrances have been fitted with composite door sets, these should have test evidence demonstrating they meet the performance requirement in Building Regulations guidance for fire resistance and smoke control from both sides. Management should confirm that suitable fire door test certificates are held and that these relate to the doors fitted. If adequacy cannot be confirmed it may be necessary for door sets to be replaced under a risk-based programme. In addition, an intrusive inspection should be carried out to confirm the adequacy of composite door set installations including the fixings and firestopping between the frame and the wall.

Flat entrance doors/frames are replacement composite fire doors (N.B. - From limited visual inspection as no flats were inspected; certification not seen; adequacy of installation not confirmed).

Flat entrance doors/frames are replacement composite fire doors

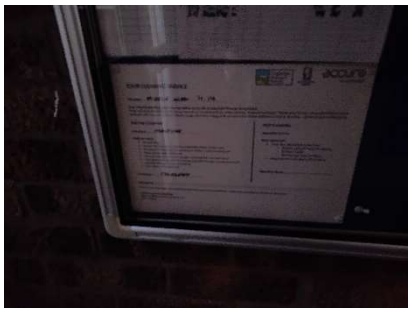
Housekeeping is of a good standard within the property and cleaning undertaken regularly, including rota displayed on notice board.

Housekeeping rota displayed on notice board

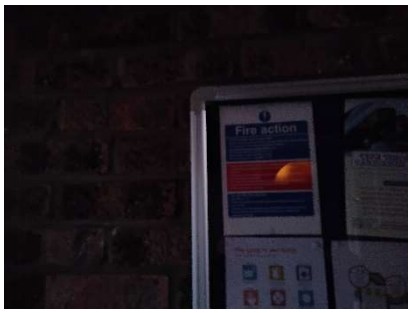
There is also ‘No Smoking’ signage in common area.

‘No Smoking’ signage in common area	
Stay Put Fire Action Notice within common area notice board
