FIRE RISK ASSESSMENT REPORT
on behalf of Colchester Borough Homes

1-15 Mumford Road
West Bergholt
Colchester
CO6 3HU

Date assessed: 31st March 2023

Project Number: 87061

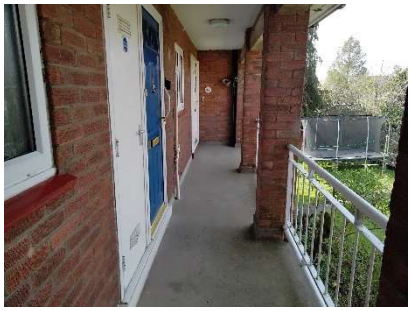
As the width of the access balconies or deck is less than 2m, it can be assumed that there is little risk of horizontal smoke spread along the balcony or deck from a fire in a flat, that would prevent residents from using the escape route. there are no additional fire hazards, such as stores or other ancillary rooms, located off the balcony or deck. Travel distances appear to be in line with that suggested in LGA - 'Fire safety in purpose-built blocks of flats' - 2012, section 5 – Escape from flats with external balcony or deck access approach.

Deck approach on first floor.

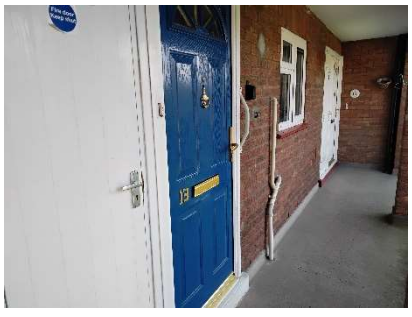
Flat entrance doors/frames appear to be replacement composite fire doors (N.B. - From limited visual inspection of flat, however, certification not seen; adequacy of installation not confirmed).

Example flat door.

Hazard: Measures to Limit Fire Spread and Development	**Priority: Medium**
Issue Ref: ES/87061/005	
Significant Findings: Flat entrance doors/frames appear to be replacement composite fire doors (N.B. - From limited visual inspection of flat, however, certification not seen; adequacy of installation not confirmed).	
Action Required: As flat entrances have been fitted with composite door sets, these should have test evidence demonstrating they meet the performance requirement in Building Regulations guidance for fire resistance and smoke control from both sides. Management should confirm that suitable fire door test certificates are held and that these relate to the doors fitted. If adequacy cannot be confirmed it may be necessary for door sets to be replaced under a risk-based programme. In addition, an intrusive inspection should be carried out to confirm the adequacy of composite door set installations including the fixings and firestopping between the frame and the wall.
