FIRE RISK ASSESSMENT REPORT
on behalf of Colchester Borough Homes

2-16 Mumford Road
West Bergholt
Colchester
CO6 3HU

Date assessed: 31st March 2023

Project Number: 86999

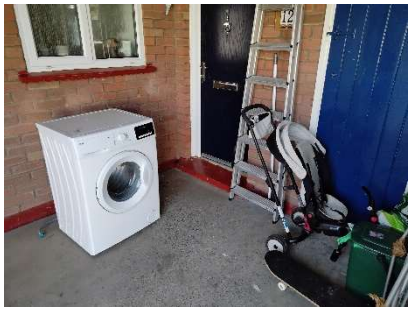
There were combustible items and trip hazards in the escape routes.

External refuse area.	
Cleaning Rota.	
Items in common area.

Hazard: Housekeeping	**Priority: Low**
Issue Ref: ES/86999/004	
Significant Findings: There were combustible items and trip hazards in the escape routes.	
Action Required: Management should contact residents to advise that the common area/escape routes should be kept free from all combustibles and/or trip hazards. A programme of regular checks should be put in place to ensure that the common area is kept clear.	
Actioned by:	**Date of Action:**
Comments Following Action:

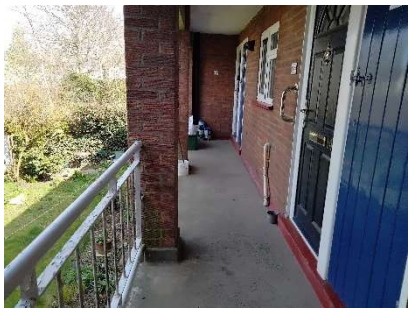
As the width of the access balconies or deck is less than 2m, it can be assumed that there is little risk of horizontal smoke spread along the balcony or deck from a fire in a flat, that would prevent residents from using the escape route. there are no additional fire hazards, such as stores or other ancillary rooms, located off the balcony or deck. Travel distances appear to be in line with that suggested in LGA - 'Fire safety in purpose-built blocks of flats' - 2012, section 5 – Escape from flats with external balcony or deck access approach.

Deck approach on first floor.
