FIRE RISK ASSESSMENT REPORT
on behalf of Colchester Borough Homes

14-24 New Kiln Road
Colchester
CO3 3QL

Date assessed: 23rd August 2022

Project Number: 85249

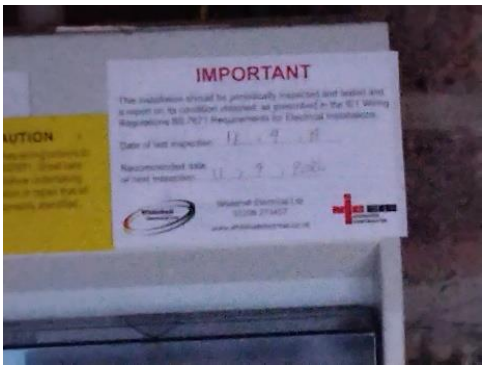
The assessor saw documented evidence that suggested that fixed wire testing has been carried out within the last five years. Date of last test: 11/09/2019.

Date test label on fixed wiring within cupboard under the stairs.
