# FIRE RISK ASSESSMENT REPORT
# on behalf of Colchester Borough Homes

## 26-36 New Kiln Road
## Colchester
## CO3 3QL

**Date assessed: 23rd August 2022**

**Project Number: 85253**

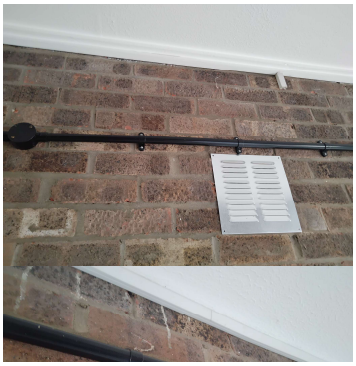
| Hazard: Means of Escape | Priority: Medium |
|---|---|
| ***Issue Ref:*** ES/85253/007 | |

| Hazard: Means of Escape | Priority: Medium |
|---|---|
| **Significant Findings:** It was noted on day of inspection that plastic saddles have been used to fix conduit in place. This could cause delay in exiting the building. | |

| Hazard: Means of Escape | Priority: Medium |
|---|---|
| **Action Required:** Metal fixings should be used to fix conduit in place to prevent cables from dropping when exposed to extreme heat. | |

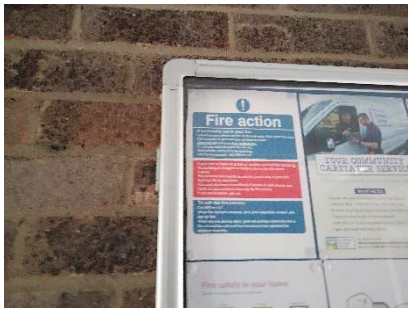
| Fire Action Notice located on notice board | |
