FIRE RISK ASSESSMENT REPORT
on behalf of Colchester Borough Homes

10-16 Nunns Road
Colchester
CO1 1EJ

Date assessed: 20th February 2023

Project Number: 86190

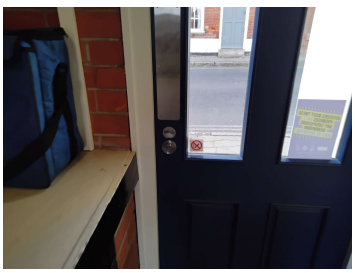
Hazard: Fire Safety Signs and Notices	Priority: Medium
Issue Ref: ES/86190/006

Significant Findings: No label was attached to door to show which way lock should be turned to open door.	
Action Required: In line with Safety Signs and Signals Regulations 1996 **-** PART 3 Fire safety signs**,** Sign to be fitted to thumb turn to show direction lock should be turned to open door.
