FIRE RISK ASSESSMENT REPORT
on behalf of Colchester Borough Homes

2-8 Nunns Road
Colchester
CO1 1EJ

Date assessed: 20th February 2023

Project Number: 86191

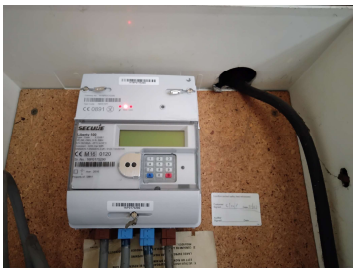
Hazard: Measures to Limit Fire Spread and Development	Priority: Medium
Issue Ref: ES/86191/004

Significant Findings: Meter cupboards are present within the communal area for each flat. Upon inspection of the meter cupboards the assessor found that cables have not been fire stopped as they enter into the cavity. A fire in these cupboards could spread into the cavity.	
Action Required: The meter cupboards should be fire stopped by a competent contractor using suitable fire resisting materials that conform to BS 476 and achieve a minimum of thirty minutes of fire resistance.	
Actioned by:	**Date of Action:**
Comments Following Action:

Meter cupboards are present within the communal area for each flat. Upon inspection of the meter cupboards the assessor found that cables have not been fire stopped as they enter into the cavity. A fire in these cupboards could spread into the cavity.

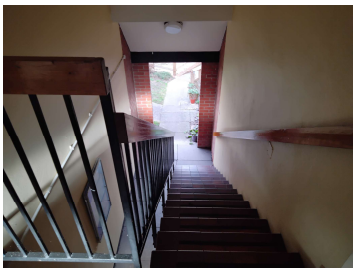
Hazard: Emergency Escape Lighting	Priority: Low
Issue Ref: ES/86191/006

Significant Findings: Although there is an emergency 'flick' test switch within the electrical cupboard, there was no evidence of LED lighting showing on the lighting fixture.	
Action Required: Organisations are required to test their emergency lighting at least once a year for the full test duration to ensure that they are still capable of providing emergency lighting for the period required. If a system fails the test, then the backup battery will have to be replaced. BS 5266-8 / BS EN 50172 dictate that the responsible persons must test all the emergency lighting systems in a building at least once a month. Emergency lighting signage guidelines require all signs and luminaries to illuminate and be present and clean. The monthly test is typically a quick 'flick' test performed to ensure that the emergency lighting switches work. Annual testing must be done to check if the lights remain on for the duration recommended by British Standard. All the lights must continue to function as they should once the test is over. Those that do not must be replaced.
