# FIRE RISK ASSESSMENT REPORT
# on behalf of Colchester Borough Homes

# 14-17 Panton Crescent
# Colchester
# CO4 3YE

**Date assessed: 6th March 2023**

**Project Number: 86913**

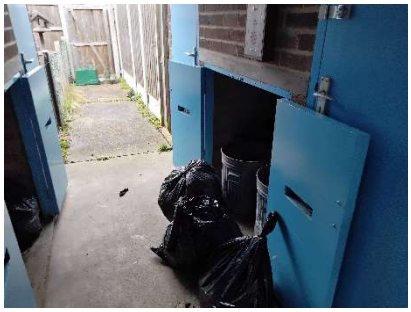
The bins are stored within the building in cupboards reducing the risk of arson.

No significant fire risks were noticed to the front or rear of the unit during the visit.

| Storage of waste | |
| Door system | |

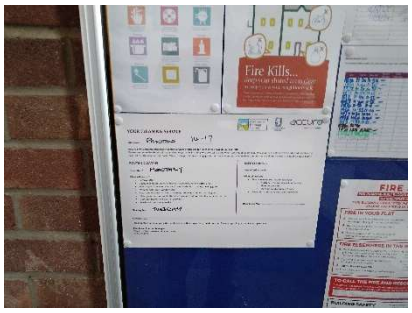
The bins are stored within the building in cupboards reducing the risk of arson.

Housekeeping is of a good standard within the property and cleaning undertaken regularly, including rota displayed on notice board.

| Cleaning rota | |
| Waste stored in cupboards | |
