FIRE RISK ASSESSMENT REPORT
on behalf of Colchester Borough Homes

22-28 Parsonsfield
Dedham
CO7 6BZ

Date assessed: 20th February 2023

Project Number: 86168

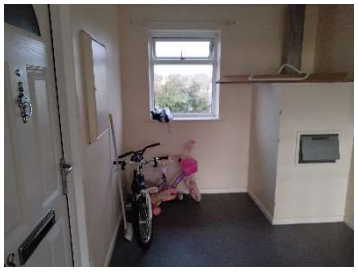
Hazard: Housekeeping	**Priority: Medium**
Issue Ref: ES/86168/002

Significant Findings: There were combustible items and trip hazards in the escape routes.	
Action Required: Management should contact residents to advise that the common area/escape routes should be kept free from all combustibles and/or trip hazards. A programme of regular checks should be put in place to ensure that the common area is kept clear.	
Actioned by:	**Date of Action:**
Comments Following Action:

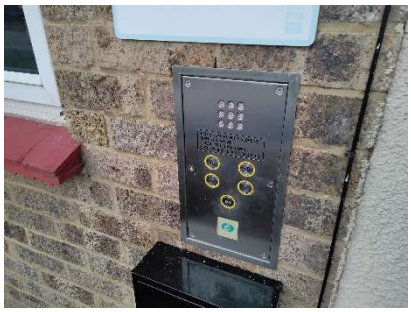
Door entry system.

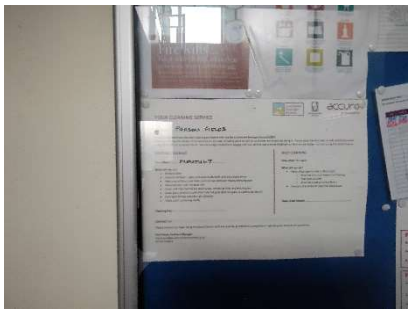
Housekeeping is of a good standard within the property and cleaning undertaken regularly, including rota displayed on notice board.

Cleaning Rota.

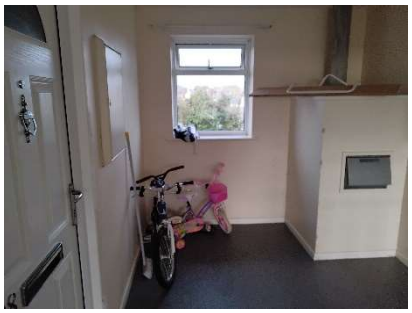
There were combustible items and trip hazards in the escape routes.
