FIRE RISK ASSESSMENT REPORT
on behalf of Colchester Borough Homes

5-11 Parsonsfield
Dedham
CO7 6BZ

Date assessed: 20th February 2023

Project Number: 86171

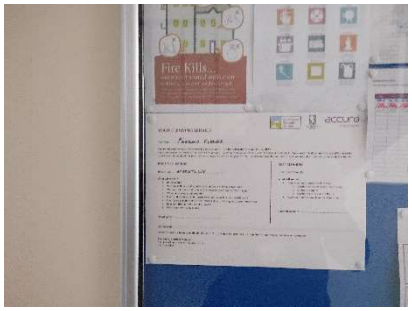
Housekeeping is of a good standard within the property and cleaning undertaken regularly, including rota displayed on notice board.

Refuse bins.	
Cleaning Rota.
