FIRE RISK ASSESSMENT REPORT
on behalf of Colchester Borough Homes

5-10 Paul Spendlove Court
Colchester
CO4 3HH

Date assessed: 15th March 2023

Project Number: 86936

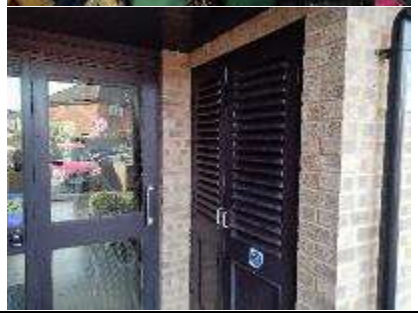
Items in common area	
Refuse areas

There were combustible items and trip hazards in the escape routes.

External waste facilities are located to the rear of the premises and near front entrance which consists of wheelie bins.

Hazard: Housekeeping	**Priority: Low**
Issue Ref: ES/86936/003	
Significant Findings: There were combustible items and trip hazards in the escape routes.	
Action Required: Management should contact residents to advise that the common area/escape routes should be kept free from all combustibles and/or trip hazards. A programme of regular checks should be put in place to ensure that the common area is kept clear.
