FIRE RISK ASSESSMENT REPORT
on behalf of Colchester Borough Homes

37-40 Port Lane
Colchester
CO1 2JE

Date assessed: 27th February 2023

Project Number: 86210

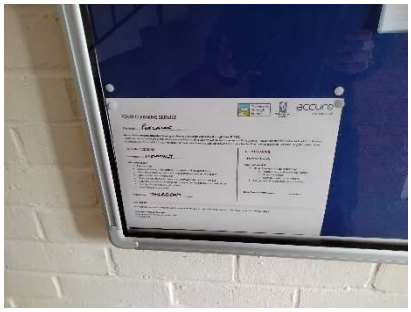
Cleaning Rota.
