FIRE RISK ASSESSMENT REPORT
on behalf of Colchester Borough Homes

1-6 Rayners Court
Colchester
CO4 5PE

Project Number: 87063

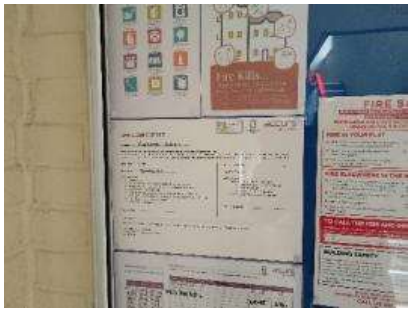
Refuse area	
Cleaning rota

General housekeeping was in good order throughout the premises.
