FIRE RISK ASSESSMENT REPORT
on behalf of Colchester Borough Homes

1-6 Redwood Court
Colchester
CO4 3LG

Date assessed: 14th March 2023

Project Number: 86938

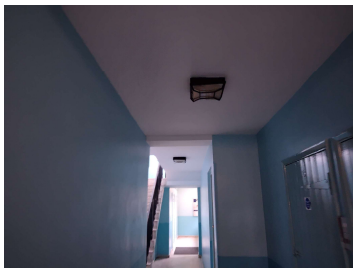
Hazard: Means of Escape	**Priority: High**
Issue Ref: ES/86938/002

Significant Findings: Various lights within the property were not working at time of inspection.	
Action Required: Adequate artificial lighting should be provided in common escape routes, such as corridors, lobbies and stairways, to enable residents and visitors to make their way safely out of the building. Regular maintenance to be undertaken on lighting and faults to be rectified as soon as possible.

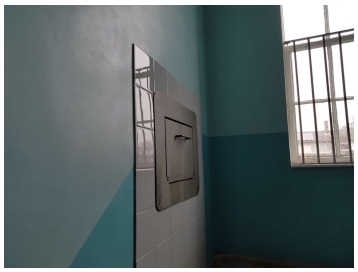
Hazard: Measures to Limit Fire Spread and Development	**Priority: Medium**
Issue Ref: ES/86938/003

Significant Findings: LGA - 'Fire safety in purpose-built blocks of flats' – 2012 Section 65 It is recommended that refuse and chute rooms should: • ideally be approached directly from the open air or by way of a protected lobby with permanent ventilation Fire safety in purpose-built blocks of flats. • be separated from all other parts of the building by fire-resisting construction (60-minute fire resistance) • not be located within protected stairways or protected lobbies.	
Action Required: Refuse chutes and access hatches were seen directly opening onto protected corridors/lobbies/stairs, so providing the potential for the spread of fire and smoke to the common escape routes. In these situations, an automatic fire-resisting shutter should be fitted at the base of the refuse chute to restrict the spread of fire and smoke from a fire in the bin room. The shutter should, as a minimum, be operated on a fixed temperature fusible link.

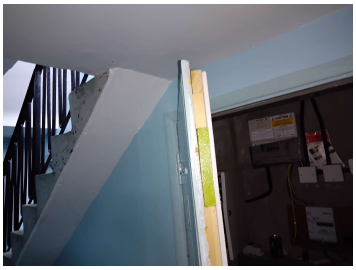
Hazard: Measures to Limit Fire Spread and Development	**Priority: Low**
Issue Ref: ES/86938/005	
Significant Findings: Electrical cupboard door may not be suitable to resist fire/smoke for a minimum of thirty minutes. There is damage to frame and door itself.

Action Required: All current personal storage cupboards should be checked for any potential ignition risks, following the assessment, doors may need to be replaced with suitable door set installations including the fixings and firestopping between the frame and the wall.	
Actioned by:	**Date of Action:**
Comments Following Action:

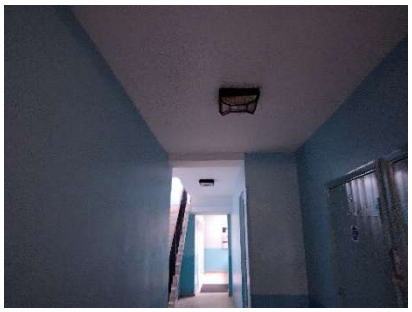
Lights not working

Openable windows on first and second floor

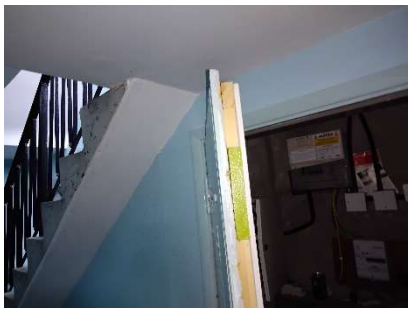
Electrical cupboard door may not be suitable to resist fire/smoke for a minimum of thirty minutes. There is damage to frame and door itself.

Vertical balconies	
Waste chutes	
Electrical cupboard door not be suitable
