FIRE RISK ASSESSMENT REPORT
on behalf of Colchester Borough Homes

2-8 Sargeant Close
Colchester
CO2 8RR

Date assessed: 20th February 2023

Project Number: 86070

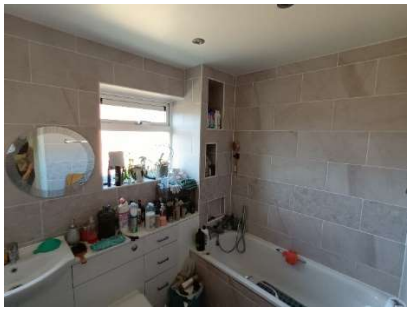
The assessor noted that there may be service riser within the flats that houses the soil and vent pipe. See significant findings.

Service riser may be boxed in.

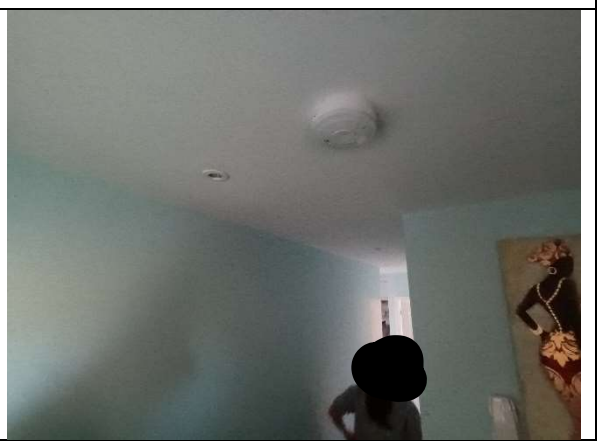
Automatic Fire Detection and Alarm to LD3 standard, the minimum required standard for these premises is LD3
