FIRE RISK ASSESSMENT REPORT
on behalf of Colchester Borough Homes

14-24 Scarfe Way
Colchester
CO4 3YR

Date assessed: 8th February 2023

Project Number: 86163

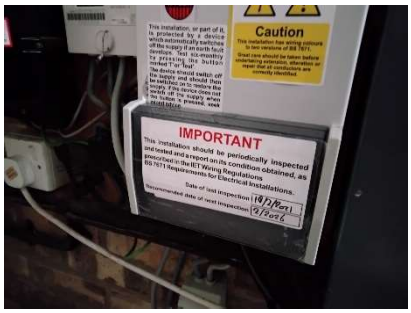
A system testing label dated was fitted to the main circuit board
