FIRE RISK ASSESSMENT REPORT
on behalf of Colchester Borough Homes

26-36 Scarfe Way
Colchester
CO4 3YR

Project Number: 86174

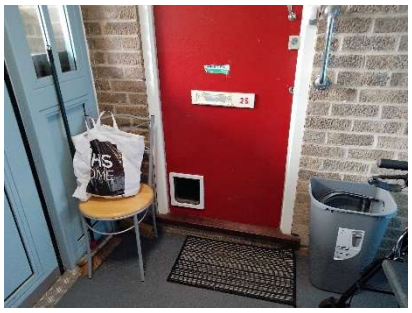
The flat entrance door 26

Hazard: Measures to Limit Fire Spread and Development	**Priority: Medium**
Issue Ref: ES/86174/004 **Significant Findings:** Access was gained to flat 26 entrance door during the assessment, however upon visual inspection of the flat entrance door, it was assessed that although the entrance door met with the building standards of the day it was of a type which may not have a working/self-closing device fitted and has been fitted with a cat flap. **Action Required:** Flats door is not compliant FD30 minimum, consideration should also be given to the fitting of combined intumescent strips and cold smoke seals to the edges of the doors or frames. If the existing door cannot be upgraded, then consideration should be given to the replacement of the doors with FD30S doors and frame sets. Any work should be completed only by competent contractors and in accordance with BS 476.	
Actioned by:	**Date of Action:**
