FIRE RISK ASSESSMENT REPORT
on behalf of Colchester Borough Homes

1-6 Smiths field
Colchester
CO1 2HP

Date assessed: 27th February 2023

Project Number: 86212

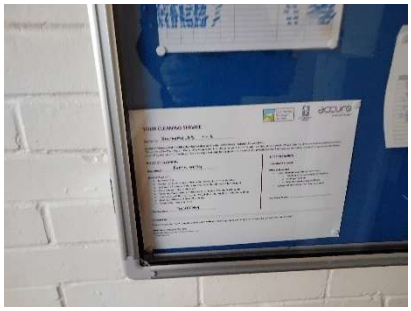
General housekeeping was in good order throughout the premises.

Refuse area.	
Cleaning Rota.

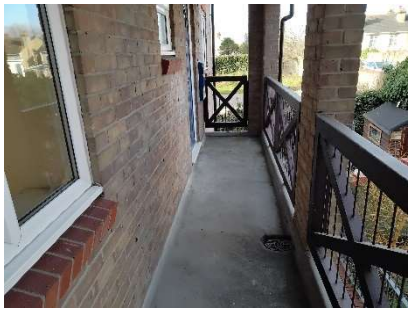
It was noted on day of inspection that plastic saddles have been used to fix conduit in place.

Plastic saddles used on conduit.	
External balconies.

Hazard: Means of Escape	**Priority: Low**
Issue Ref: ES/86212/001	
Significant Findings: It was noted on day of inspection that plastic saddles have been used to fix conduit in place.	
Action Required: Metal fixings should be used to fix conduit in place to prevent cables from dropping when exposed to extreme heat.
