FIRE RISK ASSESSMENT REPORT
on behalf of Colchester Borough Homes

1-6 Solway Court
Colchester
CO4 3JW

Date assessed: 15th March 2023

Project Number: 86980

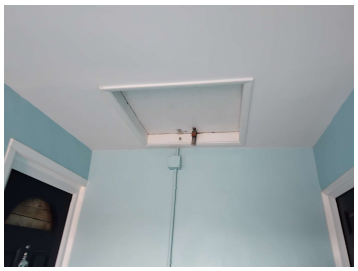
Hazard: Measures to Limit Fire Spread and Development	Priority: Medium
Issue Ref: ES/86980/007	
Significant Findings: There was no access to check the compartmentation within the roof space due to padlocks fitted and no key supplied.

Action Required: Compartmentation within the loft hatch area to be checked for compartmentation between flats. If compartmentation appears to be poor, then all findings above should be fire stopped by a competent contractor using suitable fire resisting materials that achieve a minimum of thirty minutes of fire resistance.
