FIRE RISK ASSESSMENT REPORT
on behalf of Colchester Borough Homes

58-68 Stanley Wooster Way
Colchester
CO4 3XX

Date assessed: 24th February 2023

Project Number: 86200

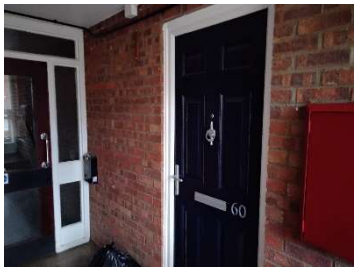
Hazard: Measures to Limit Fire Spread and Development	**Priority: Medium**
Issue Ref: ES/86200/007

Significant Findings: Flat entrance doors/frames appear to be replacement composite fire doors (N.B. - From limited visual inspection of flat 60, however, certification not seen; adequacy of installation not confirmed).	
Action Required: As flat entrances have been fitted with composite door sets, these should have test evidence demonstrating they meet the performance requirement in Building Regulations guidance for fire resistance and smoke control from both sides. Management should confirm that suitable fire door test certificates are held and that these relate to the doors fitted. If adequacy cannot be confirmed it may be necessary for door sets to be replaced under a risk-based programme. In addition, an intrusive inspection should be carried out to confirm the adequacy of composite door set installations including the fixings and firestopping between the frame and the wall.

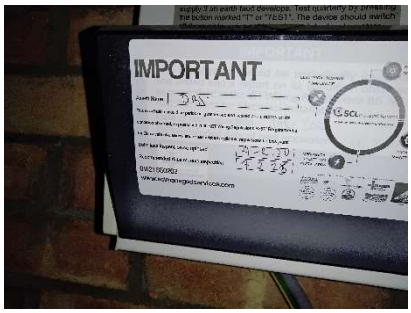
Fixed electrical inspections should not exceed 5 years. A system testing label dated 04/02/2020 was fitted to the Main Circuit Board. This means the system is due for retesting by 02/2025.

Electric meter cupboards.	
Electric test date label.

Meter cupboards are present within the communal area for each flat. Upon inspection of the meter cupboards the assessor found that cables have not been fire stopped as they enter into the cavity.

Hazard: Measures to Limit Fire Spread and Development	**Priority: Medium**
Issue Ref: ES/86200/002	
Significant Findings: Meter cupboards are present within the communal area for each flat. Upon inspection of the meter cupboards the assessor found that cables have not been fire stopped as they enter into the cavity. A fire in these cupboards could spread into the cavity.	
Action Required: The meter cupboards should be fire stopped by a competent contractor using suitable fire resisting materials that conform to BS 476 and achieve a minimum of thirty minutes of fire resistance.	
Actioned by:	**Date of Action:**
Comments Following Action:

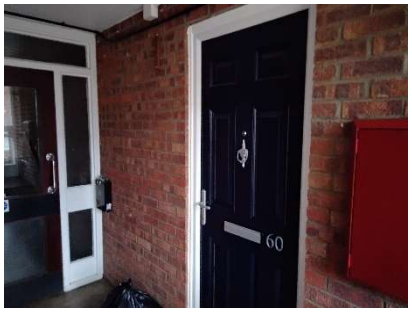
The assessor noted that there are no cold smoke seals or intumescent strips installed to the frame/door of the electrical riser cupboard or communal fire doors.

Flat entrance doors/frames appear to be replacement composite fire doors (N.B. - From limited visual inspection of flat 60, however, certification not seen; adequacy of installation not confirmed).

Meter cupboards.

Example of flat door.

No seals on electric cupboard door.	
Hole made in electrical cupboard.

Hazard: Measures to Limit Fire Spread and Development	**Priority: Medium**
Issue Ref: ES/86200/003	
Significant Findings: Compartmentation issues noted at the time of inspection include – electric cupboard on ground floor has hole from cupboard to cavity wall.	
Action Required: To prevent fire/smoke spread, the vent should be fire stopped by a competent contractor using suitable fire resisting materials that achieve a minimum of thirty minutes of fire resistance.	
Actioned by:	**Date of Action:**
Comments Following Action:

Hazard: Measures to Limit Fire Spread and Development	**Priority: Low**
Issue Ref: ES/86200/004	
Significant Findings: The assessor noted that there are no cold smoke seals or intumescent strips installed to the frame/door of the electrical riser cupboard.	
Action Required: Install cold smoke seals and intumescent strips to the top edges and both sides of the communal fire door/frame.	
Actioned by:	**Date of Action:**
Comments Following Action:

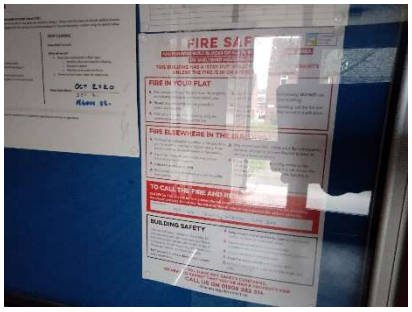
No ‘Keep Locked Shut’ signage on doors including entry doors.

No smoking signage.	
Signage on electric cupboard.	
Stay Put fire action notice.
