FIRE RISK ASSESSMENT REPORT
on behalf of Colchester Borough Homes

16-19 Stephen Cranfield Close
Colchester
CO5 7EZ

Date assessed: 9th December 2022

Project Number: 86128

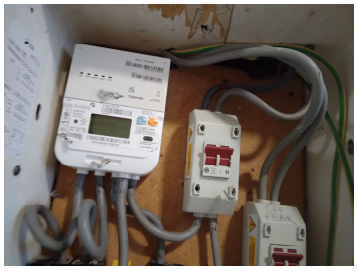
Hazard: Measures to Limit Fire Spread and Development	Priority: Medium
Issue Ref: ES/86128/002	
Significant Findings: Meter cupboards are present within the communal area for each flat. Upon inspection of the meter cupboards the assessor found that cables have not been fire stopped as they enter into the cavity. A fire in these cupboards could spread into the cavity.

Meter cupboards are present within the communal area for each flat. Upon inspection of the meter cupboards the assessor found that cables have not been fire stopped as they enter into the cavity. A fire in these cupboards could spread into the cavity.

Meter cupboards are present within the communal area for each flat

Action Required: The meter cupboards should be fire stopped by a competent contractor using suitable fire resisting materials that conform to BS 476 and achieve a minimum of thirty minutes of fire resistance.

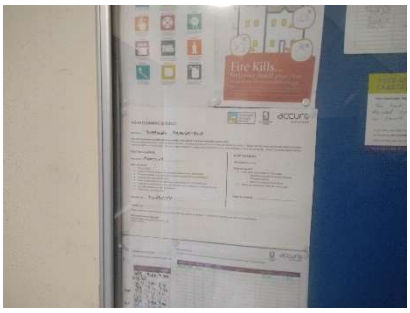
Cleaning rota displayed on notice board
