FIRE RISK ASSESSMENT REPORT
on behalf of Colchester Borough Homes

7-12 Stephen Cranfield Close
Colchester
CO5 7EZ

Date assessed: 31st August 2022

Project Number: 85244

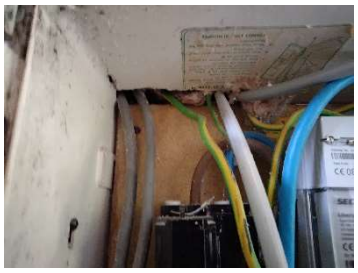
Hazard: Measures to Limit Fire Spread and Development	**Priority: Medium**
Issue Ref: ES/85244/003

Significant Findings: Meter cupboards are present within the communal area for each flat. Upon inspection of the meter cupboards the assessor found that cables have not been fire stopped as they enter the cavity. A fire in these cupboards could spread into the cavity.	
Action Required: The meter cupboards should be fire stopped by a competent contractor using suitable fire resisting materials that conform to BS 476 and achieve a minimum of thirty minutes of fire resistance.	
Actioned by:	**Date of Action:**
Comments Following Action:

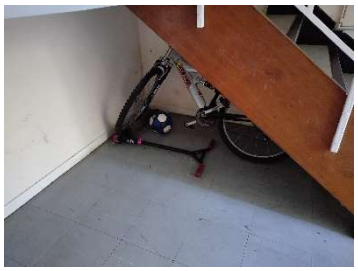
Hazard: Housekeeping	Priority: Medium
Issue Ref: ES/85244/007

Significant Findings: There were combustible items and trip hazards in the escape routes.	
Action Required: Management should contact residents to advise that the common area/escape routes should be kept free from all combustibles and/or trip hazards. A programme of regular checks should be put in place to ensure that the common area is kept clear.	
Actioned by:	**Date of Action:**
Comments Following Action:

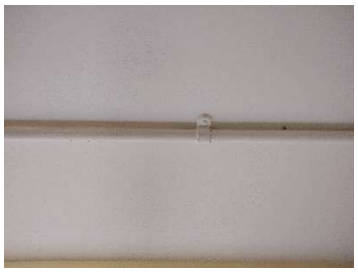
Hazard: Means of Escape	Priority: Low
Issue Ref: ES/85244/011

Significant Findings: It was noted on day of inspection that plastic saddles have been used to fix conduit in place.	
Action Required: Metal fixings should be used to fix conduit in place to prevent cables from dropping when exposed to extreme heat.	
Actioned by:	**Date of Action:**
Comments Following Action:

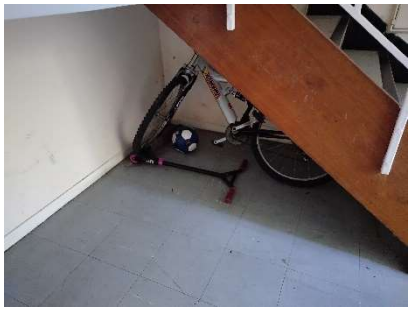
There were combustible items and trip hazards in the escape routes on first floor and under stairs on ground floor.

Items under stairs on ground floor.

Item on first floor.

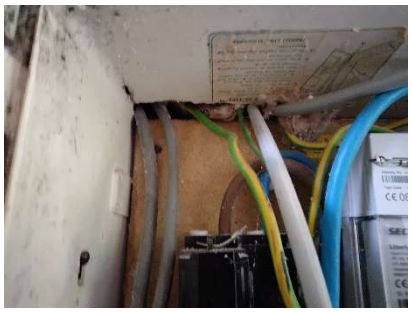
Meter cupboards are present within the communal area for each flat. Upon inspection of the meter cupboards the assessor found that cables have not been fire stopped as they enter the cavity. A fire in these cupboards could spread into the cavity.

Recessed meter cupboards outside each flat.

Flat 11 uPVC door.
