FIRE RISK ASSESSMENT REPORT
on behalf of Colchester Borough Homes

12-18 (Evens) Stockwell
Colchester
CO1 1HP

Project Number: 87065

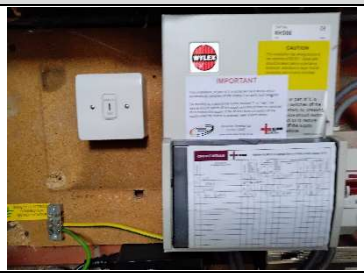
Hazard: Electrical Sources of Ignition	**Priority: High**
Issue Ref: ES/87065/001

Significant Findings: The assessor did not see any documented evidence that suggested that fixed wire testing has been carried out within the last five years.	
Action Required: Management to confirm fixed wiring has been tested within the last 5 years. If no testing has taken place within last 5 years, then testing should be undertaken as soon as possible.	
Actioned by:	**Date of Action:**
Comments Following Action:
