FIRE RISK ASSESSMENT REPORT
on behalf of Colchester Borough Homes

1-6 Sturmer Court
Colchester
CO2 8LU

Project Number: 86098

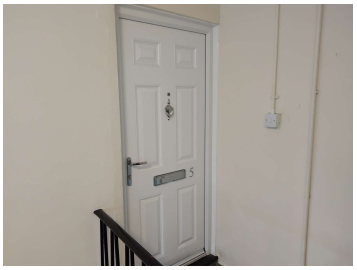
Hazard: Measures to Limit Fire Spread and Development	Priority: Medium
Issue Ref: ES/86098/005	
Significant Findings: Flat entrance doors/frames are replacement composite fire doors (N.B. - From limited visual inspection as no flats were inspected; certification not seen; adequacy of installation not confirmed).

Action Required: As flat entrances have been fitted with composite door sets, these should have test evidence demonstrating they meet the performance requirement in Building Regulations guidance for fire resistance and smoke control from both sides. Management should confirm that suitable fire door test certificates are held and that these relate to the doors fitted. If adequacy cannot be confirmed it may be necessary for door sets to be replaced under a risk-based programme. In addition, an intrusive inspection should be carried out to confirm the adequacy of composite door set installations including the fixings and firestopping between the frame and the wall.

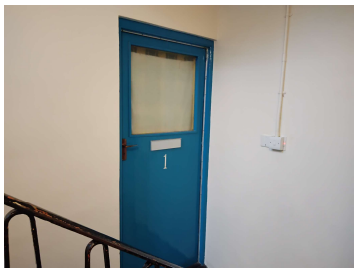
Significant Findings: Flat 1 entrance door appears to be original door timber door. As no access was possible, inspection of door was not possible.	
Action Required: Management should confirm that suitable fire door test certificates are held and that these relate to the doors fitted. If adequacy cannot be confirmed it may be necessary for door sets to be replaced under a risk-based programme.	
Actioned by:	**Date of Action:**
Comments Following Action:

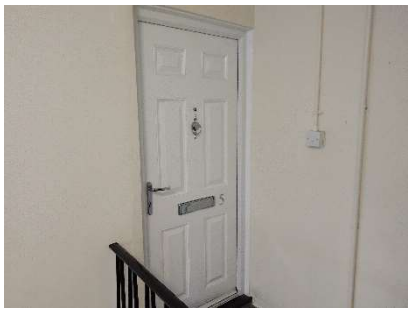
Flat entrance doors/frames are replacement composite fire doors (N.B. - From limited visual inspection as no flats were inspected; certification not seen; adequacy of installation not confirmed).

Flat entrance doors/frames are replacement composite fire doors
