FIRE RISK ASSESSMENT REPORT
on behalf of Colchester Borough Homes

41-51 Sussex Road
Colchester
CO3 3QL

Date assessed: 24th August 2022

Project Number: 85258

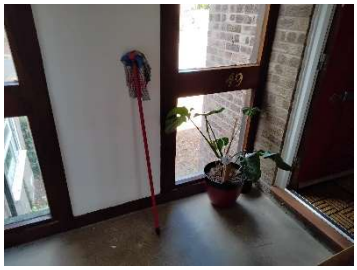
Hazard: Housekeeping	**Priority: Medium**
Issue Ref: ES/85258/002 **Significant Findings:** There were combustible items and trip hazards in the escape routes. **Action Required:** Management should contact residents to advise that the common area/escape routes should be kept free from all combustibles and/or trip hazards. A programme of regular checks should be put in place to ensure that the common area is kept clear.

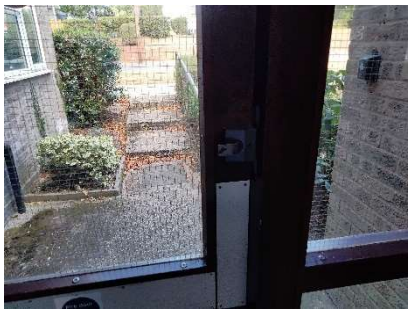
ARSON	
General – Supporting Information:	
Fires started deliberately can be particularly dangerous because they generally develop much faster and may be intentionally started in escape routes. Of all the risk-reduction measures, the most benefit may come from efforts to reduce the threat from arson.	
Observations and Photographic Evidence:	
The block entrance door is fitted with an intercom door release system and Yale lock, the main entrance and rear door was locked at the time of inspection. Bins are stored within the building in cupboards reducing the risk of arson. No significant fire risks were noticed to the front or rear of the unit during the visit.	
Intercom door release system.	
Yale locks on front and rear door.

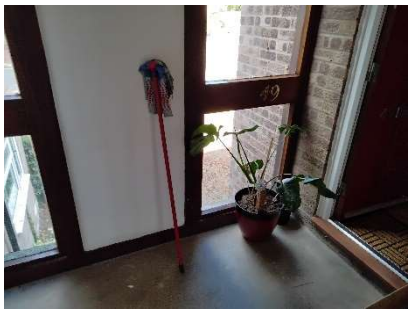
HOUSEKEEPING	
General – Supporting Information:	
Good housekeeping will lower the chances of a fire starting, so the accumulation of combustible materials in all premises should be monitored carefully. Good housekeeping is essential to reduce the chances of escape routes and fire doors being blocked or obstructed. Keep waste material in suitable containers before it is removed from the premises. If bins, particularly wheeled bins, are used outside, secure them in a compound to prevent them being moved to a position next to the building and set on fire. Never place skips against a building they should normally be a minimum of 6m away from any part of the premises.	
Observations and Photographic Evidence:	
There were combustible items under the stairs on ground floor and combustible items/trip hazards in the escape route on the 1st floor.	
Items under stairs.	
Items on 1st floor.

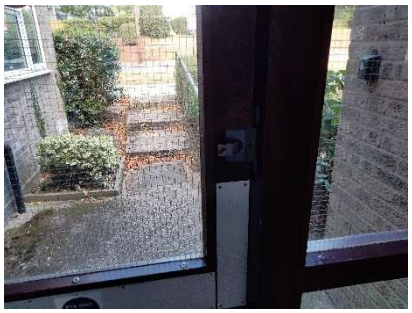
It was noted on day of inspection that plastic saddles have been used to fix conduit in place. This could cause delay in exiting the building.

Yale lock on escape doors.

Plastic saddles used to hold up conduit.

Hazard: Means of Escape	Priority: Medium
Issue Ref: ES/85258/003	
Significant Findings: It was noted on day of inspection that plastic saddles have been used to fix conduit in place. This could cause delay in exiting the building.	
Action Required: Metal fixings should be used to fix conduit in place to prevent cables from dropping when exposed to extreme heat.	
Actioned by:	**Date of Action:**
Comments Following Action:
