FIRE RISK ASSESSMENT REPORT
on behalf of Colchester Borough Homes

53-59 Sussex Road
Colchester
CO3 3QL

Date assessed: 24th August 2022

Project Number: 85259

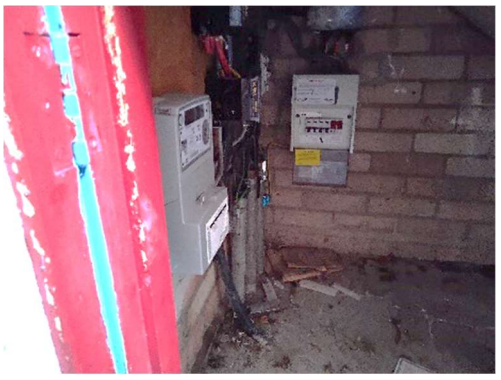
The brickwork above flat 53 has been damaged and there is a gap between common area and cavity wall or flat.	
No cold smoke seals or intumescent strips installed to the electrical cupboard frame/door.
