FIRE RISK ASSESSMENT REPORT
on behalf of Colchester Borough Homes

7-15 Swan Grove
Colchester
CO6 2DU

Project Number: 86149

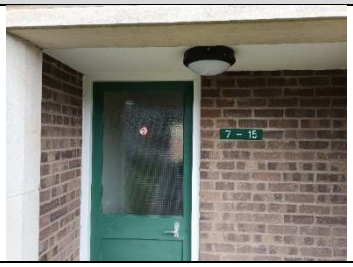
Hazard: Arson	Priority: Medium
Issue Ref: ES/86149/007

Significant Findings: The Consultant advises that the two entrances/exits cannot be secured and locked. This leaves the premises exposed to Arson in the common areas which may compromise residents means of escape in the event of a fire.	
Action Required: It is recommended that arrangements are made to secure the two final exits/entrances.	
Actioned by:	**Date of Action:**
Comments Following Action:

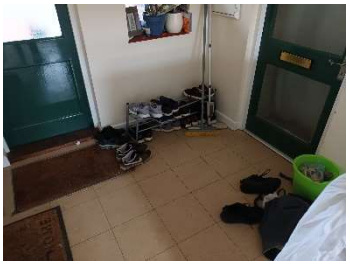
Hazard: Housekeeping	Priority: Medium
Issue Ref: ES/86149/008

Significant Findings: Combustible items were being kept to the means of escape on the top floor outside number 15 which could act as a source of fuel in the event of a fire and/or impede someone's escape from the premises.	
Action Required: It is recommended that these combustible items are removed, and information is supplied to the residents on the hazards of storing items of the means of escape, That a system is set up to monitor these areas to prevent it occurring again.	
Actioned by:	**Date of Action:**
Comments Following Action:

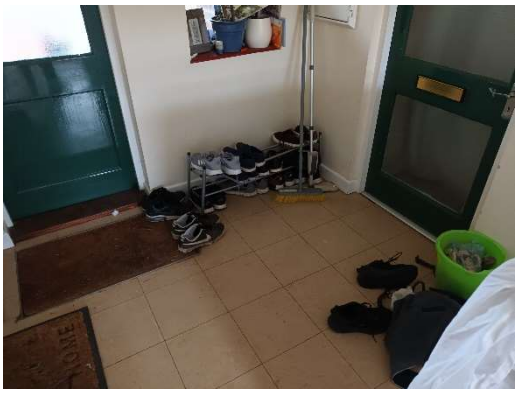
All arisings coming out of contractor's activity must be removed from the building and suitably disposed of. See significant findings.

On the means of escape.

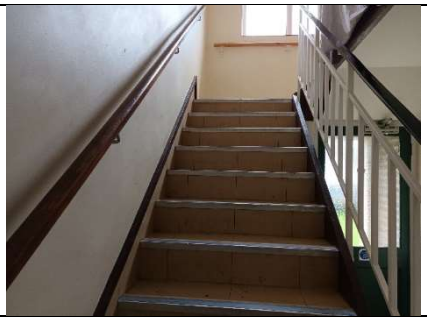
Stairs and wall linings non-combustible.

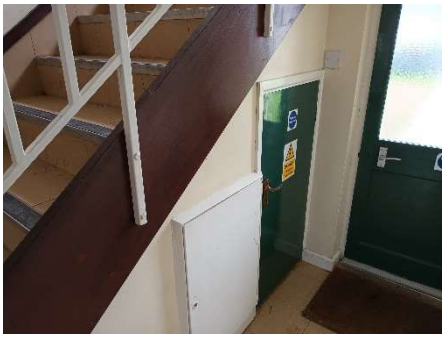
No Keep Locked Shut signs on electrical intake cupboard.

Hazard: Fire Safety Signs and Notices	Priority: Low
Issue Ref: ES/86147/003	
Significant Findings: There were no **"**keep locked shut "signs on the electrical intake cupboard on the means of escape. In the event of a fire the contents of the store may become involved in the fire rendering the means of escape unusable.	
Action Required: It is recommended that keep locked shut signs are provided and fitted to every store cupboard, including the electric intake cupboard on the means of escape.	
Actioned by:	**Date of Action:**
Comments Following Action:
