FIRE RISK ASSESSMENT REPORT
on behalf of Colchester Borough Homes

1-6 Syringa Court
Colchester
CO4 3QB

Date assessed: 17th March 2023

Project Number: 86982

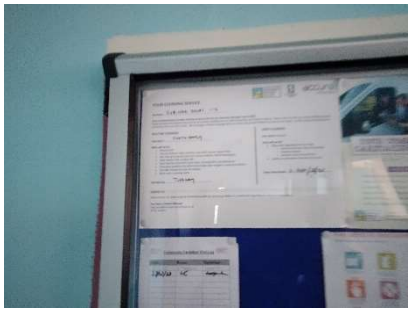
Cleaning rota

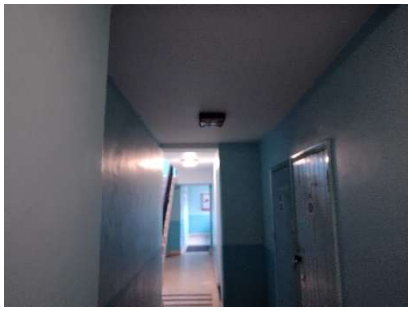
Hazard: Means of Escape	**Priority: High**
Issue Ref: ES/86982/002	
Significant Findings: Various lights within the property were not working at time of inspection.	
Action Required: Adequate artificial lighting should be provided in common escape routes, such as corridors, lobbies and stairways, to enable residents and visitors to make their way safely out of the building. Regular maintenance to be undertaken on lighting and faults to be rectified as soon as possible.	
Actioned by:	**Date of Action:**
Comments Following Action:

Various lights not fully operational
