FIRE RISK ASSESSMENT REPORT
on behalf of Colchester Borough Homes

7-12 Syringa Court
Colchester
CO4 3QB

Date assessed: 17th March 2023

Project Number: 86983

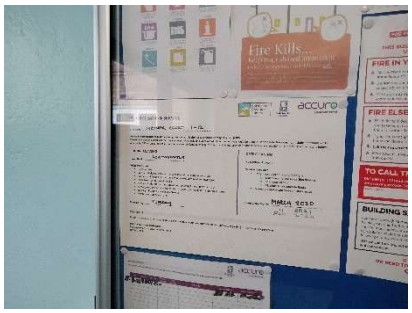
Housekeeping is of a good standard within the property and cleaning undertaken regularly, including rota displayed on notice board.

Cleaning rota

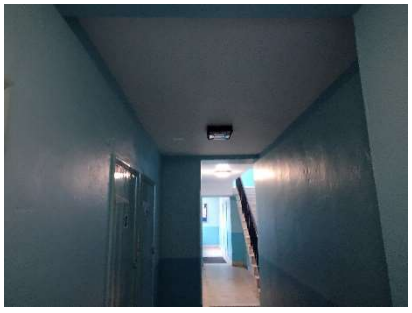
Hazard: Means of Escape	Priority: High
Issue Ref: ES/86983/002	
Significant Findings: Various lights within the property were not working at time of inspection.	
Action Required: Adequate artificial lighting should be provided in common escape routes, such as corridors, lobbies and stairways, to enable residents and visitors to make their way safely out of the building. Regular maintenance to be undertaken on lighting and faults to be rectified as soon as possible.	
Actioned by:	**Date of Action:**
Comments Following Action:

Various lights not fully operational

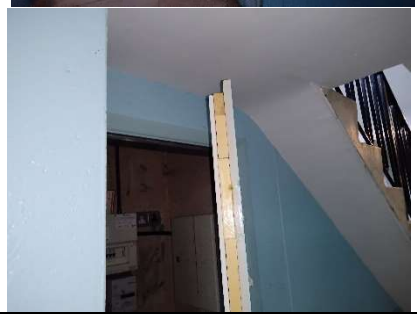
Hazard: Measures to Limit Fire Spread and Development	Priority: Low
Issue Ref: ES/86983/003	
Significant Findings: Electrical cupboard door may not be suitable to resist fire/smoke for a minimum of thirty minutes. There is damage to frame and door itself.	
Action Required: All current personal storage cupboards should be checked for any potential ignition risks, following the assessment, doors may need to be replaced with suitable door set installations including the fixings and firestopping between the frame and the wall.	
Actioned by:	**Date of Action:**
Comments Following Action:

Electrical cupboard door may not be suitable to resist fire/smoke for a minimum of thirty minutes. There is damage to frame and door itself.

Unsuitable electric cupboard door
