FIRE RISK ASSESSMENT REPORT
on behalf of Colchester Borough Homes

11-12 The Crescent
Colchester
CO6 4EH

Date assessed: 6th March 2023

Project Number: 86150

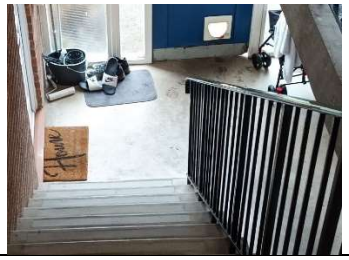
Hazard: Housekeeping	Priority: High
Issue Ref: ES/86150/007	
Significant Findings: Household items are being stored on the means of escape such as clothing, cleaning utensils, pushchair, bicycle. In the event of a fire in these combustible items may impede someone's escape from the premises.	
Action Required: It is recommended that these items are removed, and information is supplied to the residents on the hazards of storing items of the means of escape, that a system is set up to monitor these areas to prevent it occurring again.

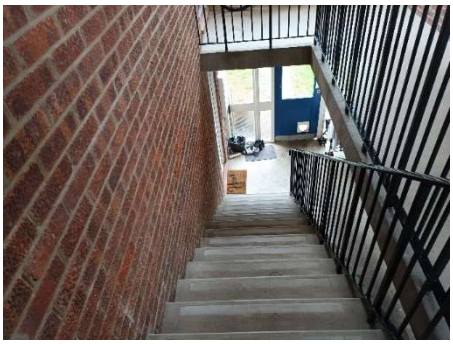
wall linings non-combustible.
