FIRE RISK ASSESSMENT REPORT
on behalf of Colchester Borough Homes

11-14 The Square
Colchester
CO2 9EB

Date assessed: 14th September 2022

Project Number: 85288

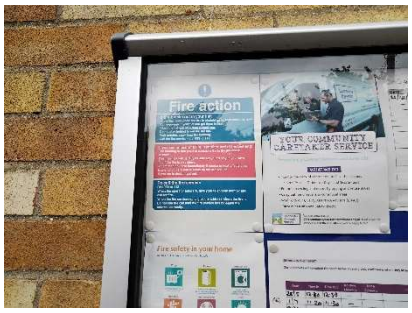
FIRE SAFETY SIGNS AND NOTICES	
General – Supporting Information:	
In simple premises, a few signs indicating the alternative exit(s) might be all that is needed. In larger and more complex premises, a series of signs directing people along the escape routes towards the final exit might be needed. Escape routes that do not constitute a normal means of leaving a building should be properly signed with signs that conform to the requirements of the Health and Safety (Safety Signs and Signals) Regulations 1996. These make use of pictogram s employing the running man, an open door, and directional arrows.	
Observations and Photographic Evidence:	
The current evacuation strategy is Stay Put as denoted by the fire action notice displayed in the common area. Directional and exit signage is not required in line with LGA - 'Fire safety in purpose-built blocks of flats' – 2012 section 63.	
Stay Put fire action notice.
