FIRE RISK ASSESSMENT REPORT
on behalf of Colchester Borough Homes

18-24 Thorpe Walk
Colchester
CO4 3TH

Date assessed: 22nd March 2023

Project Number: 87049

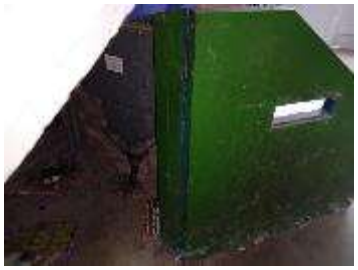
Hazard: Measures to Limit Fire Spread and Development	**Priority: Low**
Issue Ref: ES/87049/005

Significant Findings: The assessor noted that there are no cold smoke seals or intumescent strips installed to the frame/door of the electrical riser cupboard.	
Action Required: Install cold smoke seals and intumescent strips to the top edges and both sides of the communal fire door/frame.

The assessor noted that there are no cold smoke seals or intumescent strips installed to the frame/door of the electrical riser cupboard.
