FIRE RISK ASSESSMENT REPORT
on behalf of Colchester Borough Homes

25-33 Thyme Road
Colchester
CO5 0TE

Date assessed: 10th January 2023

Project Number: 86133

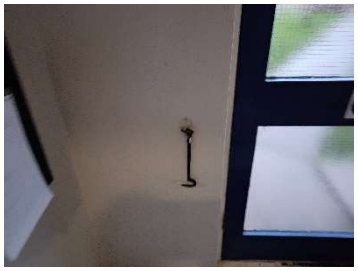
Hazard: Arson	**Priority: Low**
Issue Ref: ES/86133/002

Significant Findings: The block front entrance door was unlocked, and door was easily opened without use of key. There was also a hook internally to allow door to stay open.	
Action Required: Management should contact residents to advise that the common area access/egress doors to property should be kept locked at all times. Hook internally to be removed to avoid front door being left open.	
Actioned by:	**Date of Action:**
Comments Following Action:

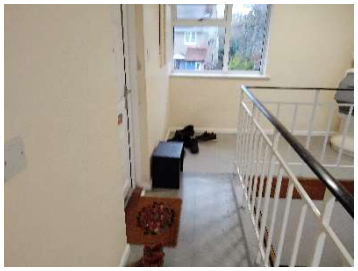
Hazard: Means of Escape	Priority: Medium
Issue Ref: ES/86133/003

Significant Findings: There were combustible items and trip hazards in the escape routes.	
Action Required: Management should contact residents to advise that the common area/escape routes should be kept free from all combustibles and/or trip hazards. A programme of regular checks should be put in place to ensure that the common area is kept clear.	
Actioned by:	**Date of Action:**
Comments Following Action:

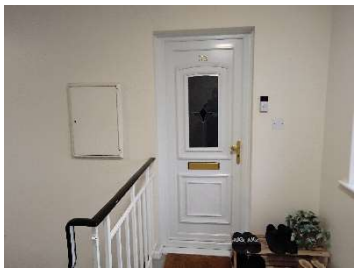
Hazard: Measures to Limit Fire Spread and Development	Priority: Medium
Issue Ref: ES/86133/006

Significant Findings: Flat 33 entrance door appears to be uPVC. This could compromise the fire resistance of the door. uPVC entrance doors are not suitable to prevent fire/smoke spread and could hinder means of escape.	
Action Required: It will be necessary for door sets to be replaced under a risk-based programme.	
Actioned by:	**Date of Action:**
Comments Following Action:

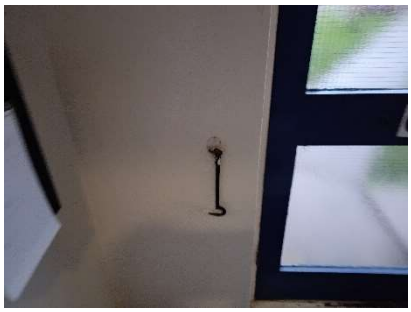
Current security levels are inadequate due to door unlocked at time of inspection; measures are in place to control unauthorised access to the common areas. The doors to the block are secured via a Yale lock.

The block front entrance door was unlocked, and door was easily opened without use of key. There was also a hook internally to allow door to stay open.

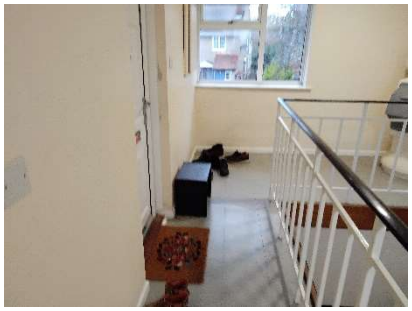
There were combustible items and trip hazards in the escape routes.
