FIRE RISK ASSESSMENT REPORT
on behalf of Colchester Borough Homes

14-20 Trinity Square
Colchester
CO1 1JR

Date assessed: 14th September 2022

Project Number: 85262

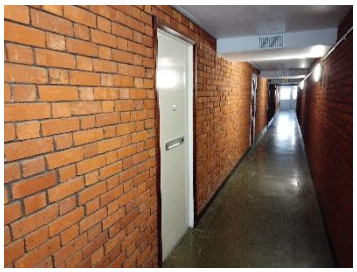
Hazard: Measures to Limit Fire Spread and Development	**Priority: Medium**
Issue Ref: ES/85262/008

Significant Findings: Various flat entrance doors appear to be original door. As no access was possible, inspection of door was not possible.	
Action Required: Management should confirm that suitable fire door test certificates are held and that these relate to the doors fitted. If adequacy cannot be confirmed it may be necessary for door sets to be replaced under a risk-based programme.	
Actioned by:	**Date of Action:**
Comments Following Action:

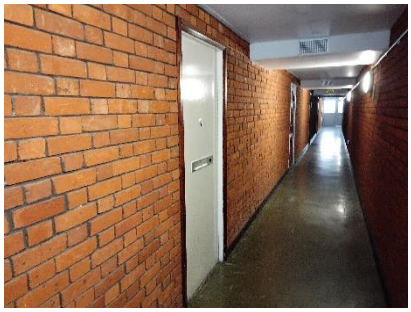
Compartmentation issues noted at the time of inspection include – ceiling on first floor have vent grills leading to communal area. It is unknown where the vent and pipe work leads to and from.

Various flat entrance doors appear to be original door.

Various flat entrance doors/frames are replacement composite fire doors.	
ceiling on first floor have vent grills leading to communal area. It is unknown where the vent and pipe work leads to and from.
